Nonsurgical repair of a large iatrogenic lateral root perforation using calcium-enriched mixture cement: A case report

Asgary, Saeed () "Nonsurgical repair of a large iatrogenic lateral root perforation using calcium-enriched mixture cement: A case report," *Journal of Dental Sciences*: Vol. 21: Iss. 2, Article 91.

Correspondence

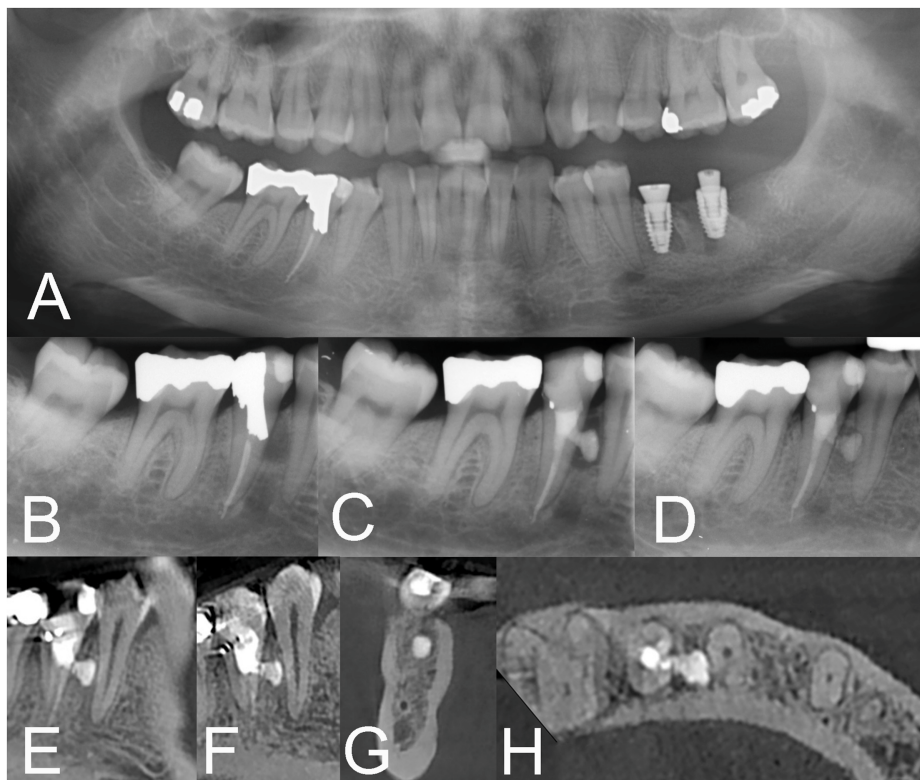
A 39-year-old female presented with severe pain from the mandibular right second premolar, which had been root-filled with amalgam one year prior (Fig. 1A). A periapical radiograph revealed a large, well-defined radiolucent lesion on the mesial root surface, indicative of a massive lateral perforation (Fig. 1B). The treatment plan involved nonsurgical retreatment and perforation repair.

The patient became asymptomatic within one week. At the 27-month recall, the tooth was functional and asymptomatic. Periapical radiography demonstrated complete resolution of the lateral radiolucent lesion (Fig. 1D). Cone-beam computed tomography (CBCT) confirmed three-dimensional bone regeneration and complete bone healing in the perforation area, with the sagittal, coronal, and axial planes showing excellent osseous integration and tolerance to the extruded CEM biomaterial (Fig. 1E–H).

Figure 1 Radiographic sequence of the diagnosis, management, and 27-month follow-up of a large iatrogenic lateral root perforation on the right mandibular second premolar. (A) Pre-operative panoramic radiograph showing the tooth following initial root canal treatment and coronal restoration with amalgam; the patient was asymptomatic at this time. (B) Periapical radiograph taken one year later upon the patient's return, presenting with severe pain, revealing a large, well-defined radiolucent lateral lesion associated with the mesial root surface, indicative of a massive perforation. (C) Immediate post-operative periapical radiograph following the removal of the previous amalgam root canal filling, chemomechanical preparation, and meticulous sealing of the perforation site with calcium-enriched mixture cement; note the unintentional extrusion of biomaterial into the lateral periodontal space. The patient's symptoms resolved completely within one week. (D) Twenty-seven-month recall periapical radiograph demonstrating complete resolution of the previous radiolucent lesion and the tooth being fully functional and asymptomatic. (E–H) Cone-beam computed tomography images at the 27-month recall, confirming three-dimensional bone regeneration and complete healing in the perforation area: (E and F) sagittal, (G) coronal, and (H) axial planes. These images also illustrate the excellent biocompatibility and good tolerance of the surrounding bone to the extruded biomaterial.

After obtaining informed consent, the tooth was properly isolated. The old amalgam coronal restoration and root canal fillings were precisely removed. The canal was meticulously cleaned with a 5.25 % NaOCl solution. The perforation site was identified on the mesial wall. After drying the canal, the perforation defect was bio-obtured (i.e., filled and sealed),^{2,3} with CEM cement (BioniqueDent, Tehran, Iran) according to the manufacturer's instructions. An observable extrusion of biomaterial into the periodontal space was noted (Fig. 1C). The coronal cavity was then sealed with composite resin (Z100, 3M ESPE, St. Paul, MN, USA).

capacity to facilitate hard tissue deposition, i.e., cementogenesis and osteogenesis.^{4,5} Its success here, even in the presence of initial extrusion, can be attributed to its high pH, which creates an antimicrobial environment, and its ability to release calcium and hydroxyl ions, promoting hard tissue formation. The complete healing of a large endodontic defect, as confirmed by CBCT images, suggests that CEM cement can create a favorable environment for periodontal healing and regeneration, even in challenging root perforation cases.
